Kiribati Water Resources Assessment & Management Project

NONOUTI, KIRIBATI WATER RESOURCES ASSESSMENT

SOPAC Preliminary Report 141

April 2004

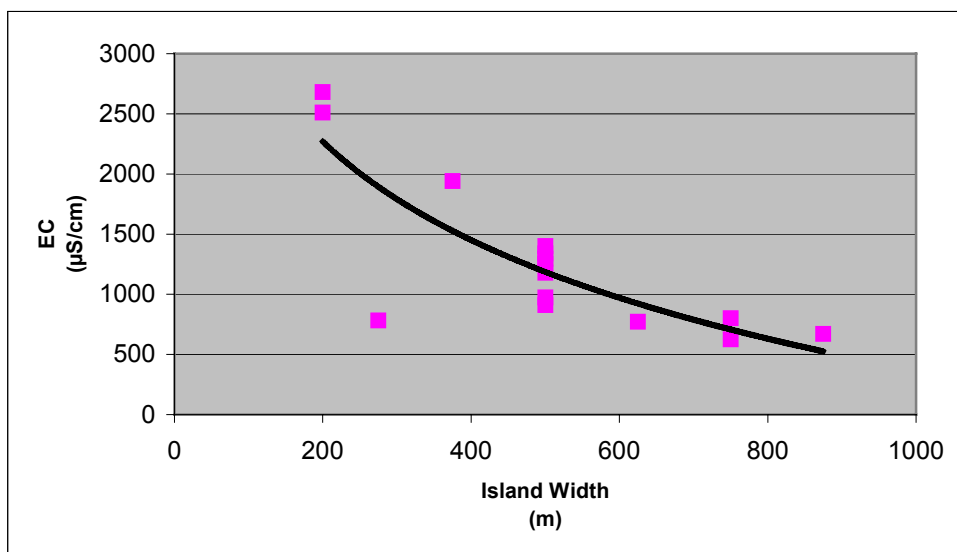
Figure 2. Conductivity vs. Island Width Nonouti.

From the above one can conclude that the salinity of groundwater is a problem in the northern islands of Nonouti with current EC readings of water from their only source, exceeding 2,500 µS/cm. This equates to chloride concentrations well above the WHO guidelines for drinking water of 250 mg/l. Other values measured on Nonouti indicate potable water from Teaubu towards the south until Taboiaki. Regular measurements of selected wells should be performed on a quarterly basis by the water technician.

When EC readings are compared with rough estimates for the width of the island, measured from the well site to the ocean, some correlation can be detected. The graph below in Figure 2 shows fresher water (lower EC readings) in the wider parts of the island.

- A well survey sheet for regular EC measurements should be designed and a monitoring schedule should be introduced including measurements at pumped water supplies (every 3 months).
