COMMON FAILURE MODES IN PRESSURISED PIPELINE SYSTEMS

Third-party damage	✓	✓	✓	✓	✓	✓	✓	✓	Third party damage should not be considered a pipe failure as such.

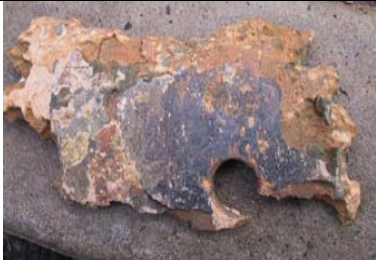
<p>Corrosion adjacent brass tapping ferrule</p>

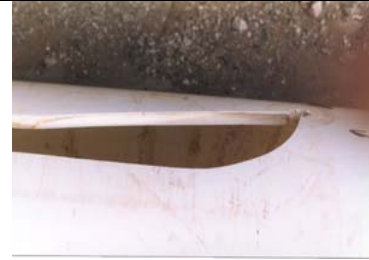
<p>Blow out at PVC tapping ferrule connection</p>

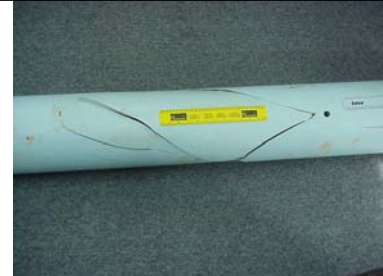
<p>Fracture of PVC-U pipe adjacent to tapping point</p>
<p>Leaking joint</p>	<p>Water leakage through the joint. Often a result of a displaced rubber ring joint or debris left in the ring groove during installation of RRJ pipes. Lead jointed steel pipe can also leak.</p>

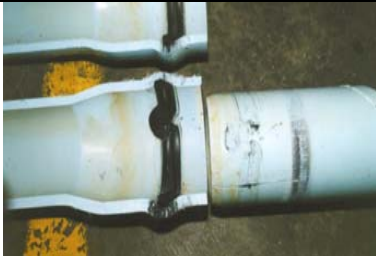
<p>Displaced rubber ring in PVC pipe</p>

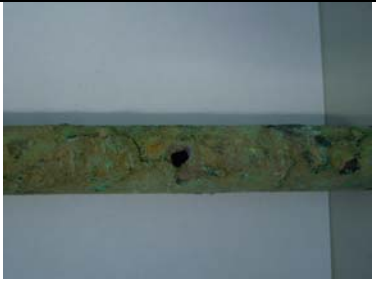
<p>Copper pipe perforation from external corrosion</p>

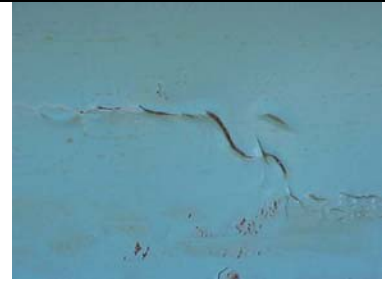
<p>Manufacturing defects in PVC-U pressure pipe</p>

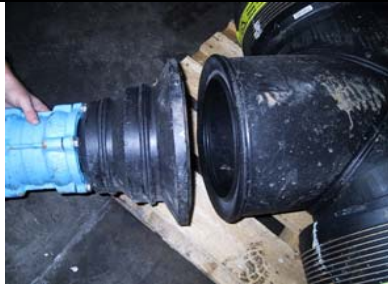
Split adjacent to butt weld

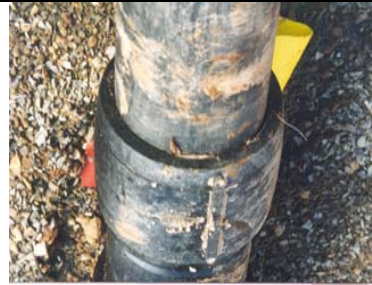
Leakage from electrofusion fitting
