Water Quality and Health

Safe Water Delivered Safely

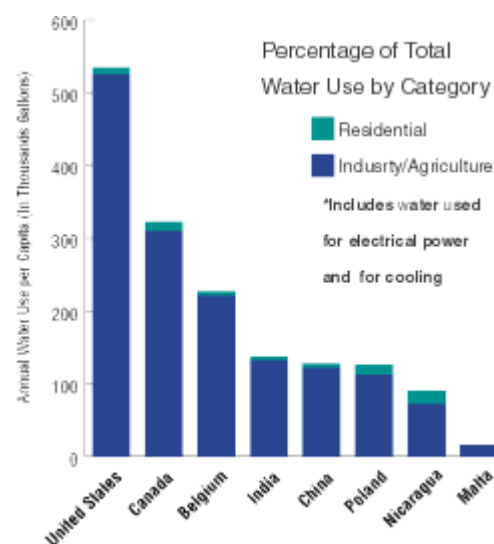
Water Use in Different Countries

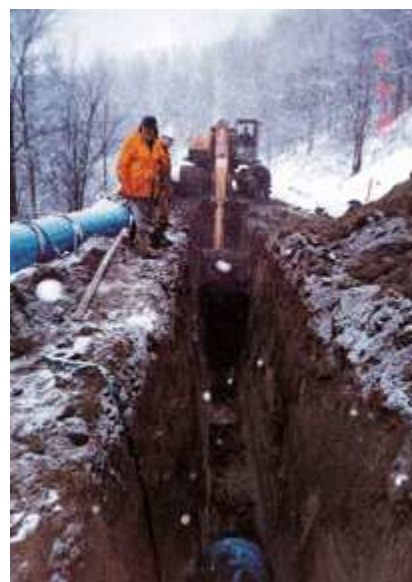
Common Causes of Main Breaks

Types of Water Main Pipes:

- Vinyl
- Cast Iron
- Ductile Iron
- Asbestos Cement
- Reinforced Concrete

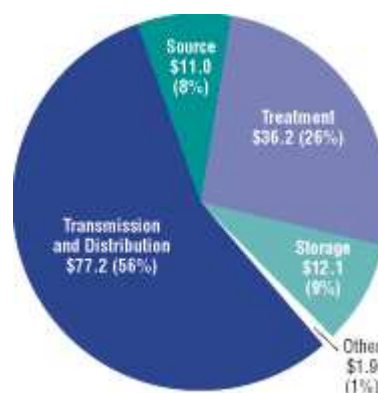
Water Distribution Costs

(in Billions of January '95 Dollars)

In terms of cost, taxpayers in Canada spend an average of \$82 million every year to repair broken water mains -- an estimated \$2,500 in repair costs alone for each pipe failure. And the Federation of Canadian Municipalities estimates that they lose about \$650 million worth of water every year. The U.S. Environmental Protection Agency (EPA), after conducting a national survey among U.S. water systems, recently found that the U.S. will need to invest about \$138 billion to repair the water transportation infrastructure. According to EPA, the single largest category of need is the replacement of existing water distribution pipes - about \$77 billion.
