WATER RESOURCES ASSESSMENT OF THE MORA RIVER

Editors:
Dr. Bruce Thomson
Dr. Abdul-Mehdi Ali

Water Resources Program
University of New Mexico
Albuquerque, NM 87131

June 2009

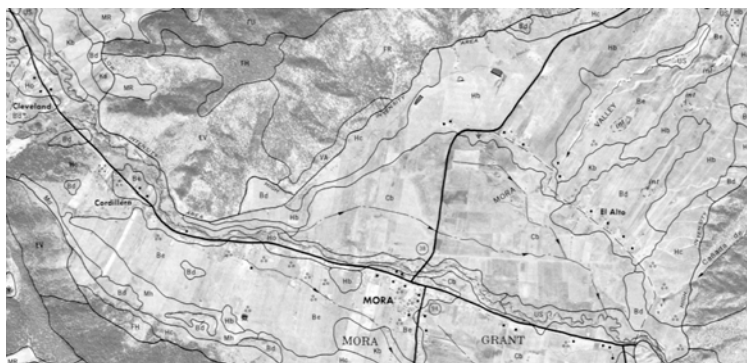
Figure 3 Soil Survey of Mora County (United States Dept. of Ag., Soil Conservation Service, 1981)

The USDA (1981) describes the soils in the Mora region as originating from parent material of metamorphic, igneous and sedimentary rocks. They vary in age from Precambrian to Holocene. Principal soil formation occurred during the Quaternary Period. Broad alluvial deposits occur on the eastern plains. The valleys consist mostly of Mollisols (highly erodible) and are dark colored due to warmer conditions and vegetation, while the higher mountain regions have higher organic matter with non-decomposed leaf litter due to higher precipitation and cooler climates. Soils here tend to have thicker layers and higher occurrence of leached profiles. In the western region, rocks consist of gray and red shale, thin strata of gray limestone and sandstone beds. The Sangre de Cristo Mountains consist of various colored shales, siltstone, arkosic sandstone and clay shale. Climate is the major factor affecting vegetation, parent material, drainage, soil temperatures and precipitation. Figure 3 presents a soil survey of the Mora County region.

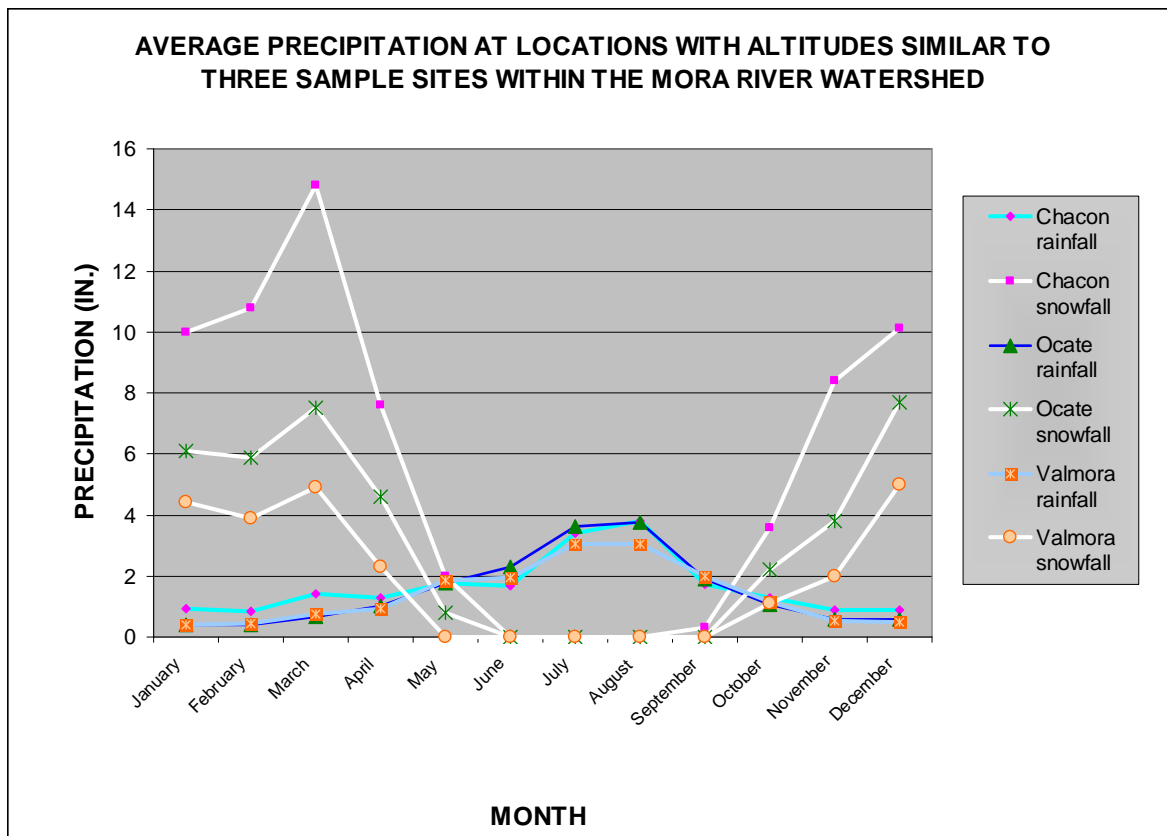
Figure 5. Monthly average precipitation in the Mora River watershed (WRCC, accessed June 2009).

Average monthly precipitation data from the three NOAA weather stations is plotted in Figure 5 and is consistent with the double peaks for stream runoff shown in Figure 8. Differences in rainfall during the historical periods and the years 1998-2007 for the Gascon and Ocate stations are slight and variable. Valmora received less rainfall in the more recent ten year period when compared to the long-term average. It appears that rainfall has decreased recently, however due to the short period of record it is not known whether this is due to normal variability of rainfall, drought, or climate change.

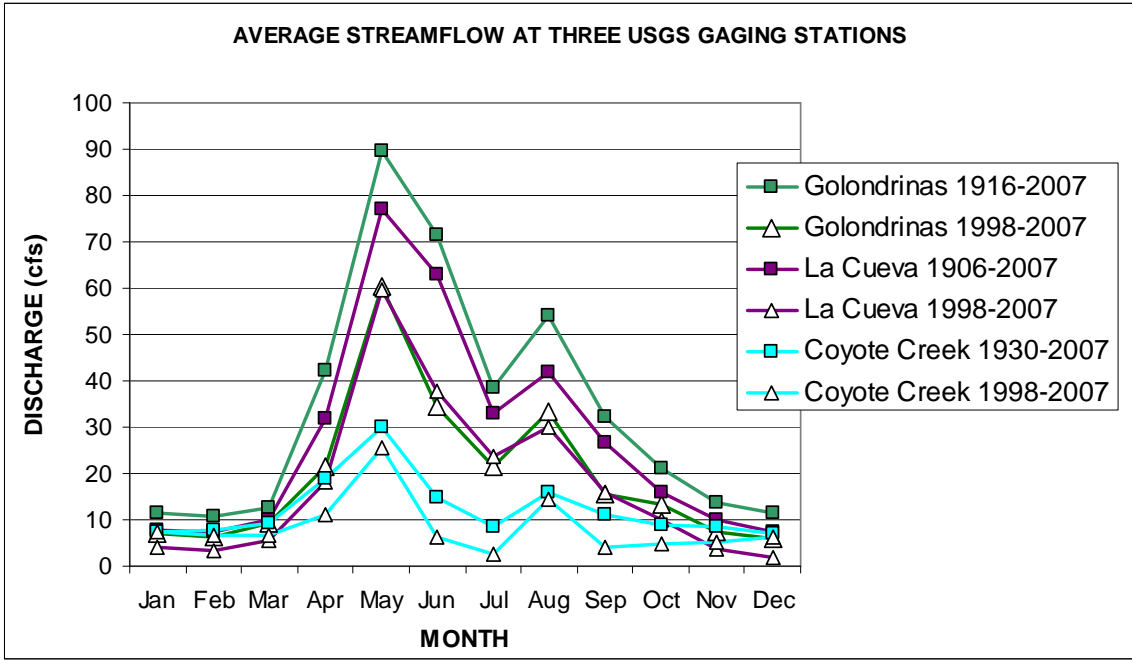
Figure 8. Average stream flow of the Mora River at Golondrinas and La Cueva, and of Coyote Creek (USGS, 2008).

Figure 8 compares average stream flow between the ten most recent available years with the complete records from three USGS gaging stations on the Mora River watershed: the Mora River near Golondrinas for the time periods of 1916-2007 and 1998-2007, the Mora River at La Cueva for the time periods 1906-2007 and 1998-2007, and Coyote Creek (Mora tributary) for the time periods 1930-2007 and 1998-2007. Peak runoff due to snowmelt occurs in late spring and early summer, and a second peak occurs during late summer due to monsoon activity. The plots illustrate decreases in stream flow from 1998-2007 when compared to the historical averages for all three stations. The difference may be greater than two-hundred percent (e.g., June at the Mora River near Golondrinas). This may be the result of drought, increased water diversions for irrigation, or both. Several gaging stations in the watershed are no longer in operation or are located on acequias and operate only on a seasonal basis.

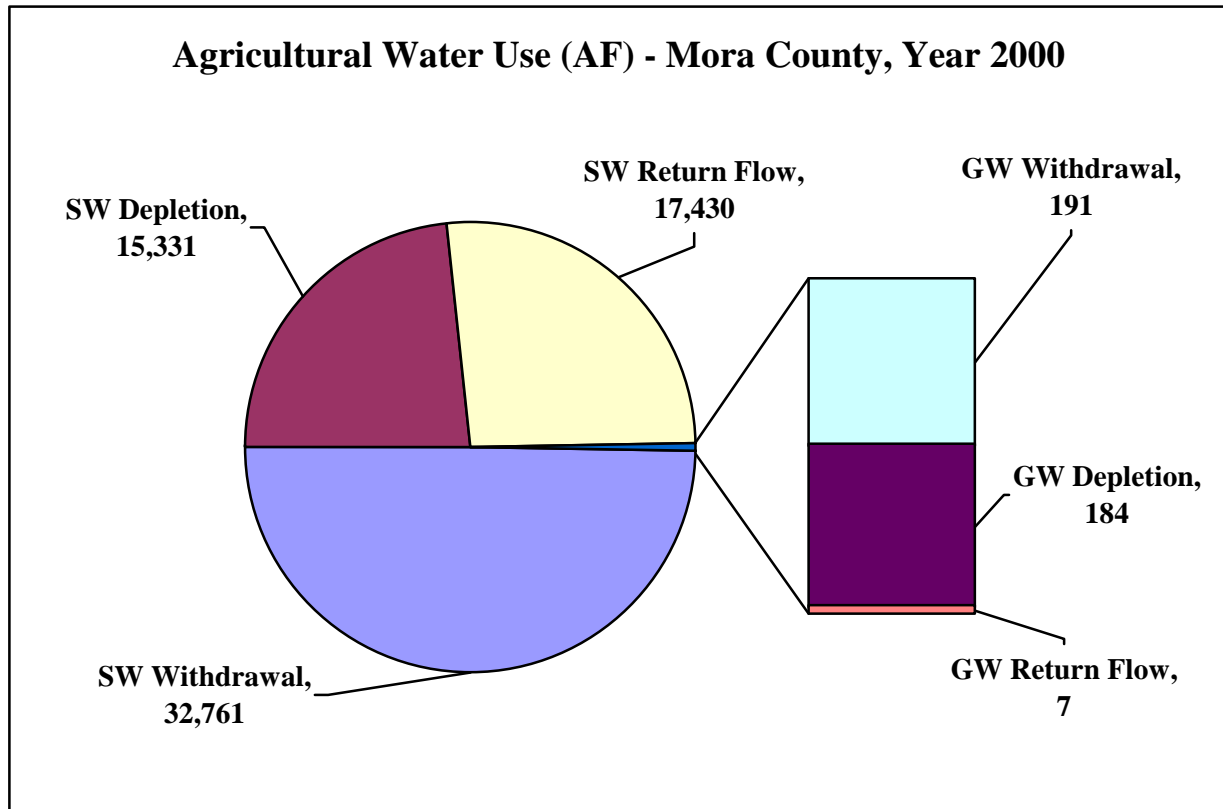
Figure 13. Agricultural water use in Mora County (NMOSE, 2000).

Figure 13 shows agricultural water use in the county for the year 2000. Surface water (SW) and ground water (GW) withdrawals, depletions and return flows are shown.

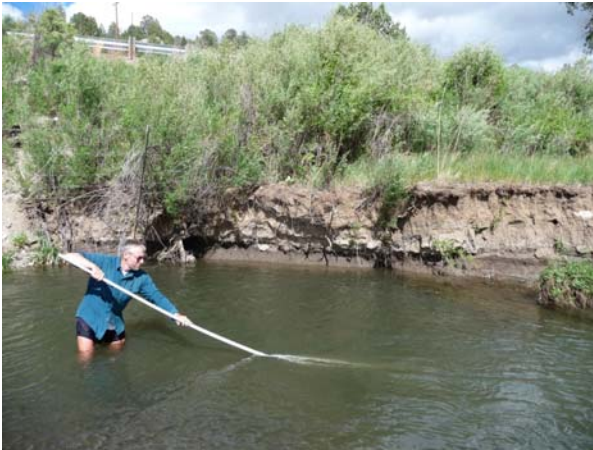
Figure 14. Measurement of thalweg depth at EMAP site number 2 downstream from the community of Mora.

- The thalweg depth (the deepest point in the stream's cross section) was measured every ten feet for 400 feet centered on the baseline transect using a surveyor's rod (Figure 14).
- At each transect, bank-full height and bank-full width (i.e., river height and width at a nominal two-year maximum flow) were identified and measured, as was the wetted-width (i.e., current width of river). Bank angle was recorded. An undercut bank was noted as having a negative bank angle.
- River bottom composition was characterized by selecting locations at each bank and at 25%, 50% and 75% across each transect. The surveyor's rod was placed at each location and the underlying substrate was estimated by determining the size of the particle(s) directly beneath the rod and the fractional embeddedness of the particle using EMAP criteria.

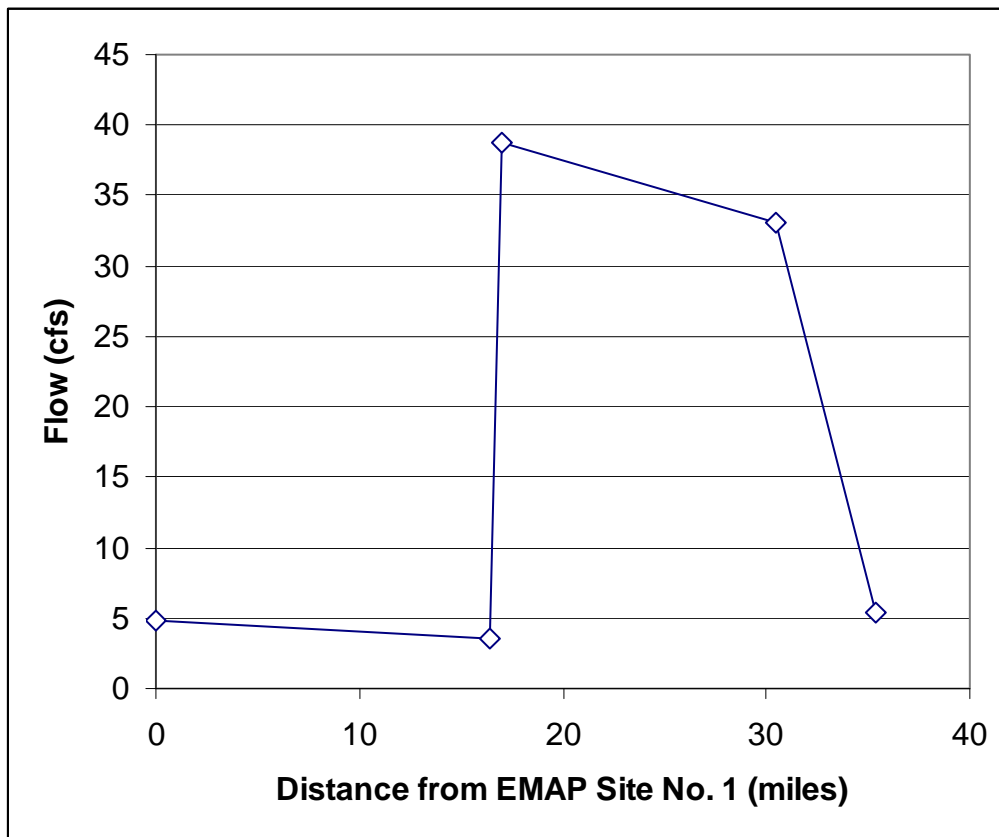
Figure 15. Flow in the main stem of the Mora River as a function of distance downstream from EMAP Site No. 1 near the headwaters.

The highly variable flow in the main stem of the Mora River is illustrated in Figure 15. It is recommended that future studies measure flow in the river between the head waters (mile 0 on this chart) and the community of Mora at the Allsup's gasoline station (mile 16) to better understand the nature of flow in the river and the effects of acequia diversions.

The significance of this measurement is that the lack of water in the river in the Mora Valley is almost certainly due principally to the diversion of surface water for agricultural use. Further,

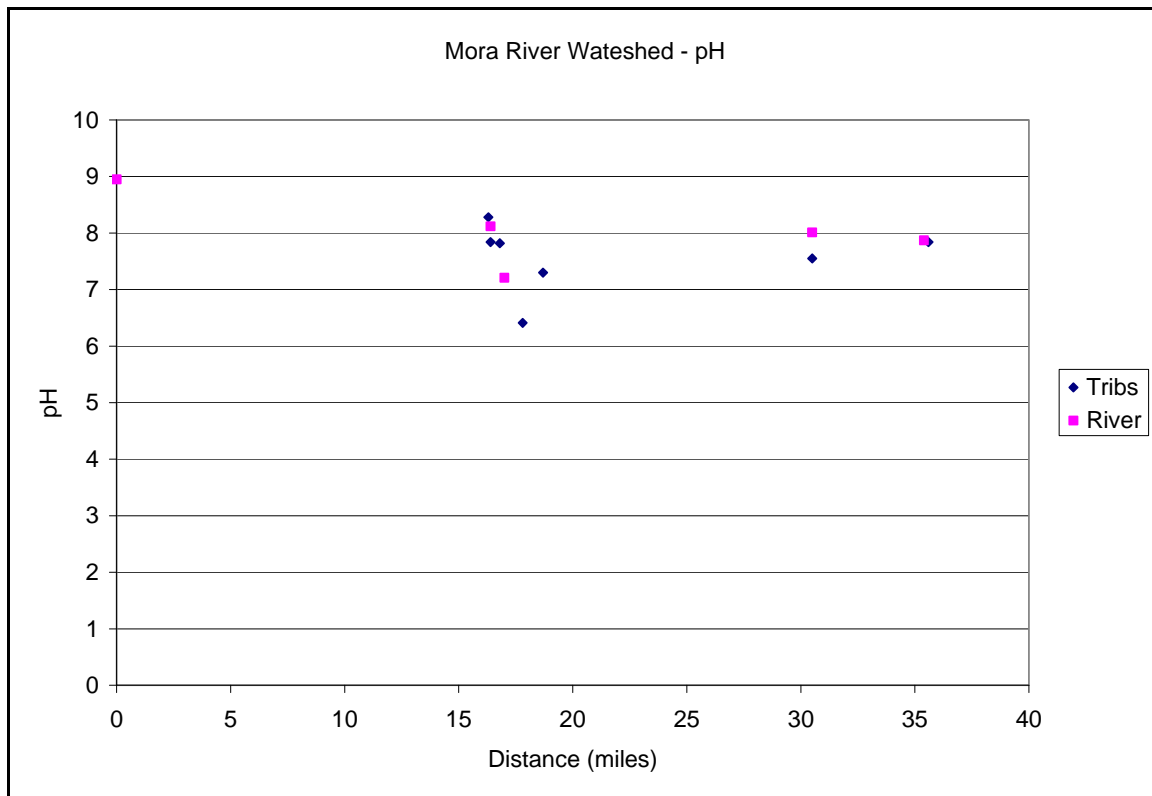
Figure 16. pH measurements in the Mora River, its tributaries and acequias plotted versus distance from EMAP site number 1.

There is little change in pH and DO along the length of the main stem of the Mora River, although there is some variability in the acequias and tributaries (Figure 16 and Figure 17). The ideal pH for trout is less than 8, therefore since nearly all the sampled reaches are below this level all sampled reaches have a safe pH for trout (Seals, 2009). Dissolved oxygen (DO) levels should be greater than 5-6 mg/L to support a healthy cold water fish population (North Carolina State University, 1998) and it is clear that water in the Mora River meets this criteria.

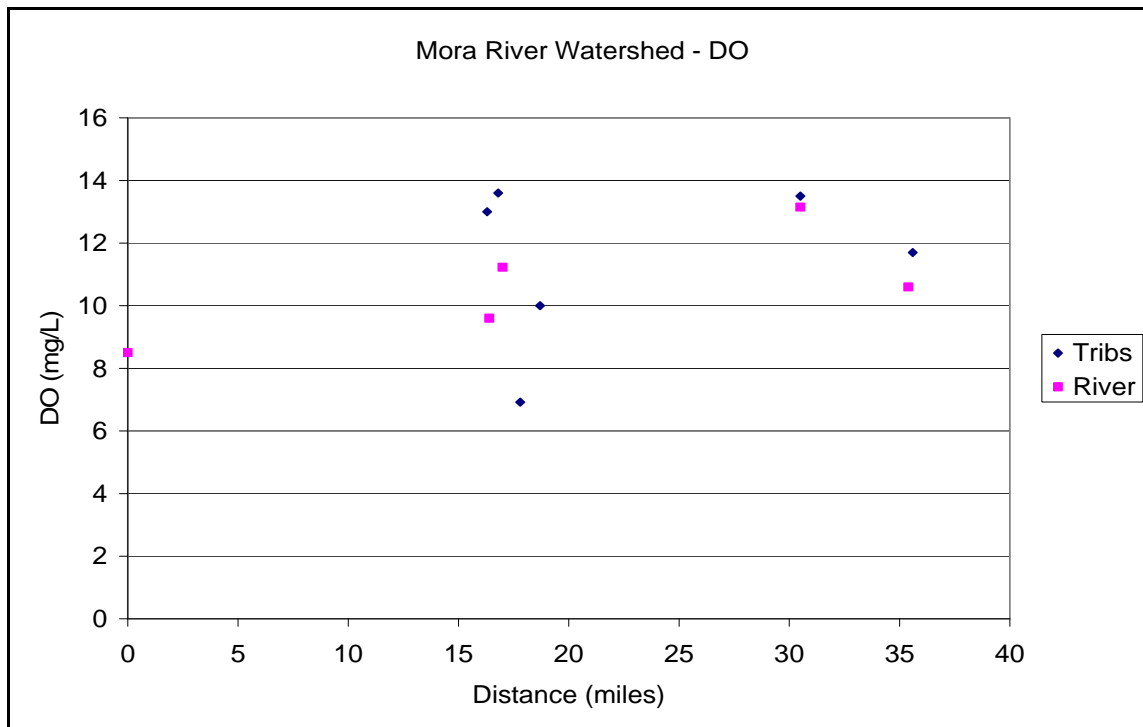
Figure 17. DO measurements in the Mora River, its tributaries and acequias plotted versus distance from EMAP site number 1

Note that at several locations in the lower part of the watershed the DO concentrations were substantially greater than the saturation value. The saturation concentration is that which occurs when the solution is in equilibrium with the atmosphere. The DO saturation levels in the Mora River watershed ranged from about 8 mg/L to near 10 mg/L, depending on elevation and water temperature, yet several of the sampling sites had DO concentrations much higher than this, particularly in the Mora Valley and below (Figure 17). It is believed that these high levels are the result of photosynthetic oxygen production by aquatic plants, particularly algae, which are stimulated by elevated nutrient concentrations. This observation is consistent with the finding of impairment of the Mora River by the NMED SWQB (SWQB, 2007a).

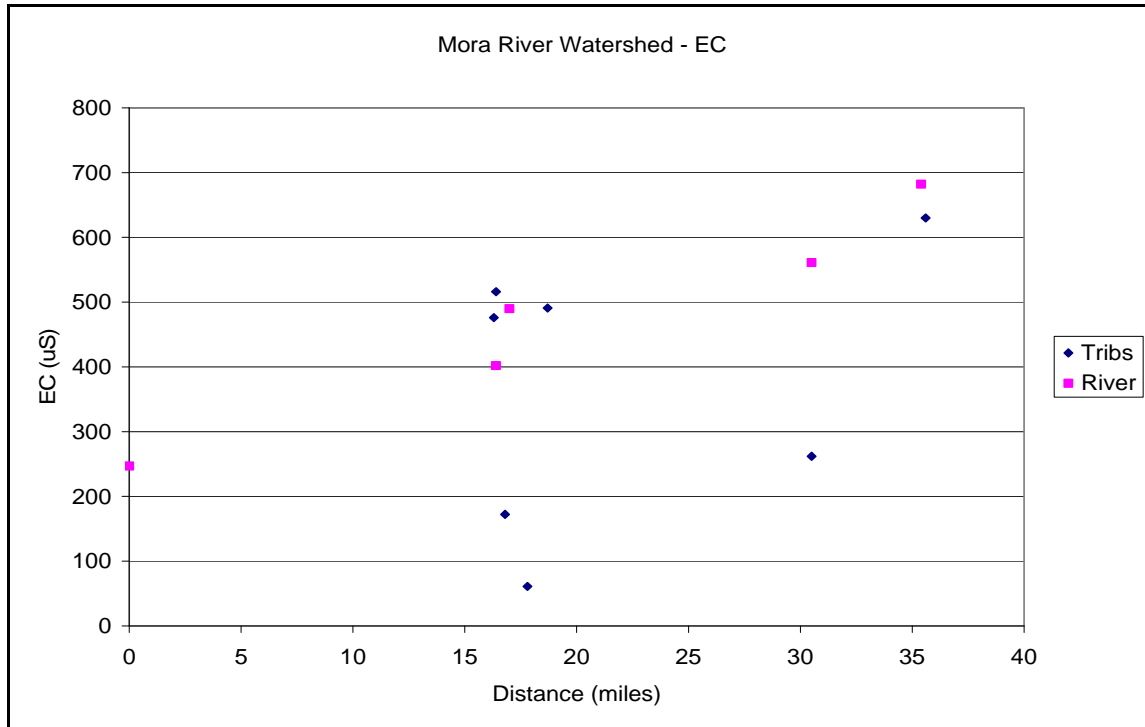
Figure 18 Electrical conductivity measurements in the Mora River, its tributaries and acequias plotted versus distance from EMAP site number 1

Field measurements of EC along the length of the Mora River are shown in Figure 18. These show a very clear increase in the ionic content of the water as one proceeds downstream. This increase is principally due to evaporation, especially in lower and warmer parts of the watershed, which increases the concentration of dissolved constituents. This is especially important for irrigation return flows. An example is the EC in the Trambley acequia (516 μS) which drains several square miles of pasture and is much higher than the EC in the river above the community of Mora (402 μS). The surface water standard for EC upstream from Highway 434 is 500 μS (20.6.4.309 NMAC).

Data comparing TDS and EC in water samples in the Mora River watershed have been measured by the SWQB (2007b). Thus, the approximate TDS of the river immediately above the confluence with the Sapello River is 480 mg/L. There are no surface water quality criteria for EC in the reach of the Mora between Shoemaker and Highway 434.

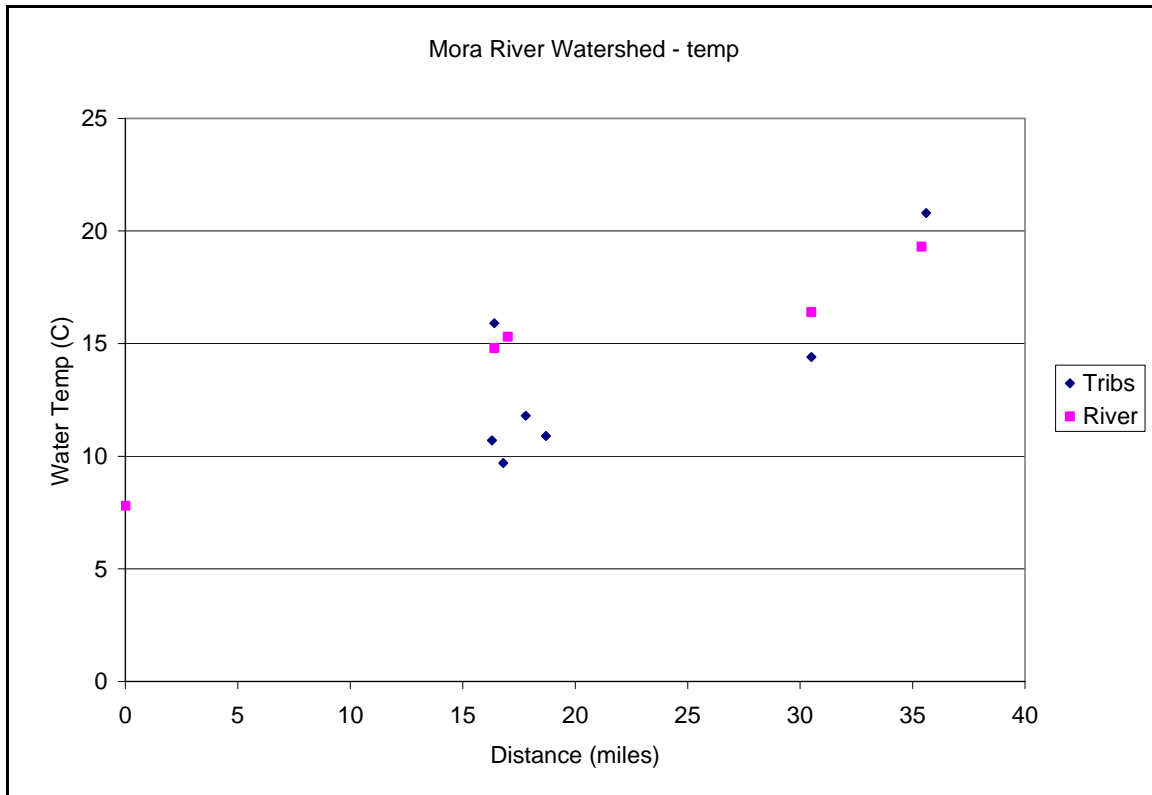
Figure 19 Temperature measurements in the Mora River, its tributaries and acequias plotted versus distance from EMAP site number 1

Temperature measurements in the Mora River, its tributaries and acequias are plotted in Figure 19. The maximum water temperature for trout habitat is 60° F, or 15.5° C (Seals, Appendix D). The New Mexico stream standards for the river upstream from highway 434 is 68 °F (20 °C) (20.6.4.309 NMAC) and below highway 434 it is 77 °F (25 °C) (20.6.4.307 NMAC). Temperature standards were not violated during this study, but it should be remembered that this study was conducted early in the summer near the peak of spring runoff. Furthermore, the weather throughout the duration of the study was unseasonably cool which likely affected water temperatures measured during this study.

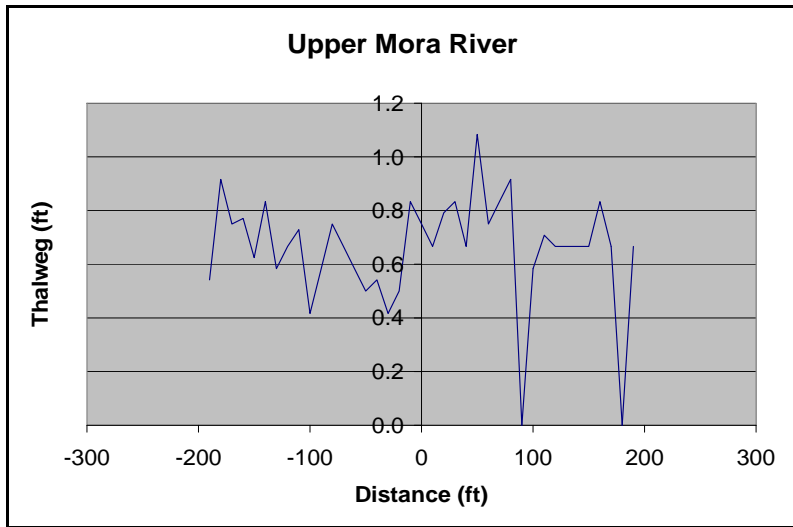
Figure 20 Plots of thalweg depths at the three EMAP sites

Figure 20 shows plots of the thalweg depths at each of the three EMAP sites on the Mora River. As shown on the graphs, the thalweg depth at the upper reach is nearly 1.2 ft deep, at the middle reach is nearly 4.5 ft deep, and at the lower reach is nearly 2.5 ft deep. Within each site the thalweg varies greatly, which is an indicator of a healthy stream system as variations in channel depth provides habitat for aquatic organisms, while shallow riffle areas produce turbulence which aerates the water.

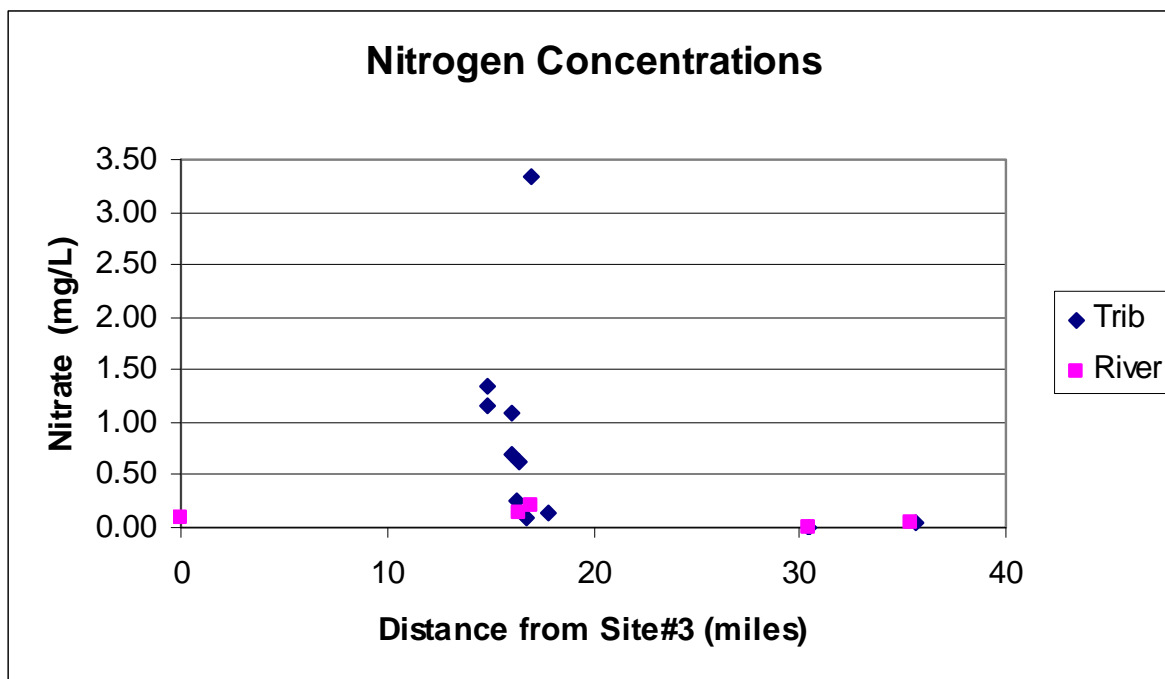
Figure 21 Nitrate nitrogen concentrations in the Mora River, its tributaries and acequias plotted versus distance from EMAP site number 1 (mg NO₃⁻/L reported as N).

Concerns about high plant nutrient concentrations in the water due to livestock impact, agriculture activities, and on-site wastewater treatment and disposal were considered in this study. Nitrate (NO_3^-) concentrations were low but present at sufficiently high levels to contribute to eutrophication. Average nitrate concentration for the reach analyzed was .094 mg/L reported as nitrogen. In comparison the analysis of the Sapello River nitrate concentration at Watrous (Thomson & Ali, 2008) was not detectable above the MDL. The NMED SWQB (2007) report found a 0.03 mg/L concentration of total nitrogen within the same reach. Figure 21 shows nitrate concentrations in the Mora River and other water samples versus distance from the upper Mora EMAP site.

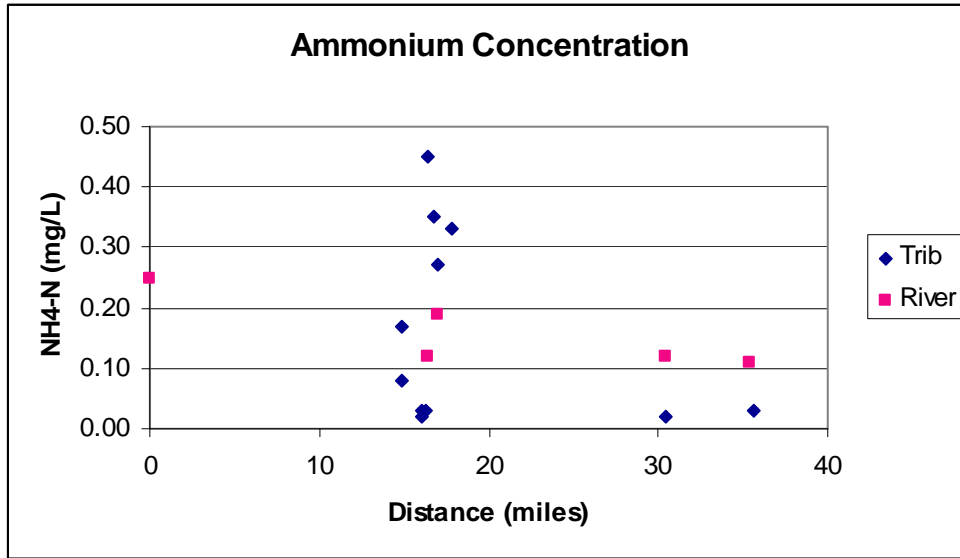
Figure 22 Ammonium nitrogen concentrations in the Mora River, its tributaries and acequias plotted versus distance from EMAP site number 1 (mg NH₄⁺/L reported as N)

The filtered ammonium concentrations (NH₄-N mg/L) in the water samples are shown in Figure 22. The ammonium concentrations in the Mora River range from 0.25 to 0.11 mg/L while the concentrations in the other samples range from .05 to .45 mg/L. Results are shown in Table 9 and Figure 22.

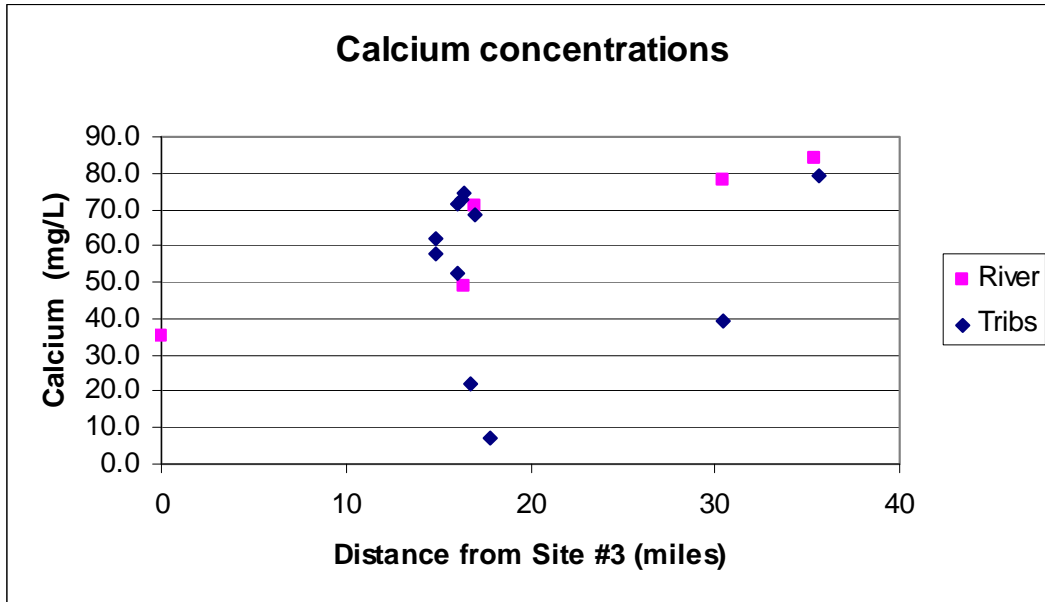
Figure 23 Calcium concentrations in the Mora River, its tributaries and acequias plotted versus distance from EMAP site number 1

Calcium concentrations in ground water samples were roughly twice as high as those in the upper reaches of the Mora River. It is believed that they are due to the soil characteristics in the Mora watershed, many of which have high fractions of calcareous minerals such as limestone (CaCO₃²⁻). Calcium concentrations in the river and acequias increase as the river flows eastward, presumably due to the influence of weathering of basin soils and concentration increases due to evaporative water losses. Figure 23 shows calcium concentrations in the Mora River and other waters versus distance from the upper Mora EMAP site.

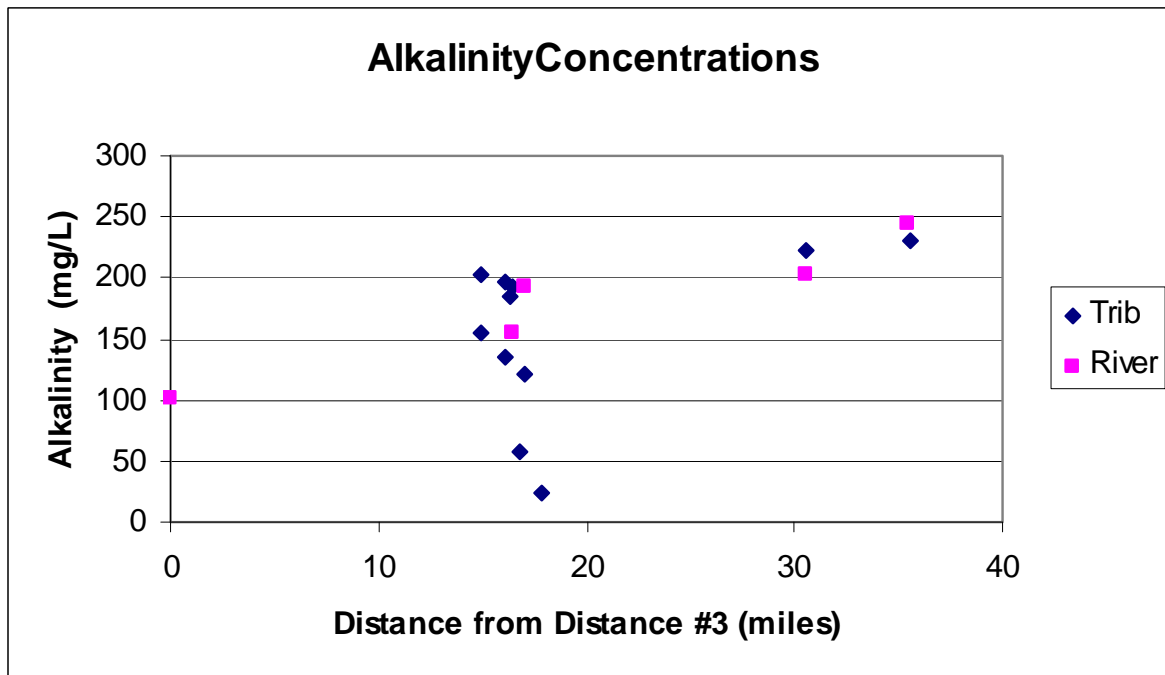
Figure 24 Alkalinity in the Mora River, its tributaries and acequias plotted versus distance from EMAP site number 1 (mg CaCO₃/L)

Alkalinity was measured at each water quality sampling site. It varied within the sample region from 23 mg CaCO₃/L to 244 mg CaCO₃/L. Concentrations increased further down the river likely due to dissolution of soil minerals in the basin and concentration by evaporation. Figure 24 depicts alkalinity along the sampled reaches of the river and other waters.

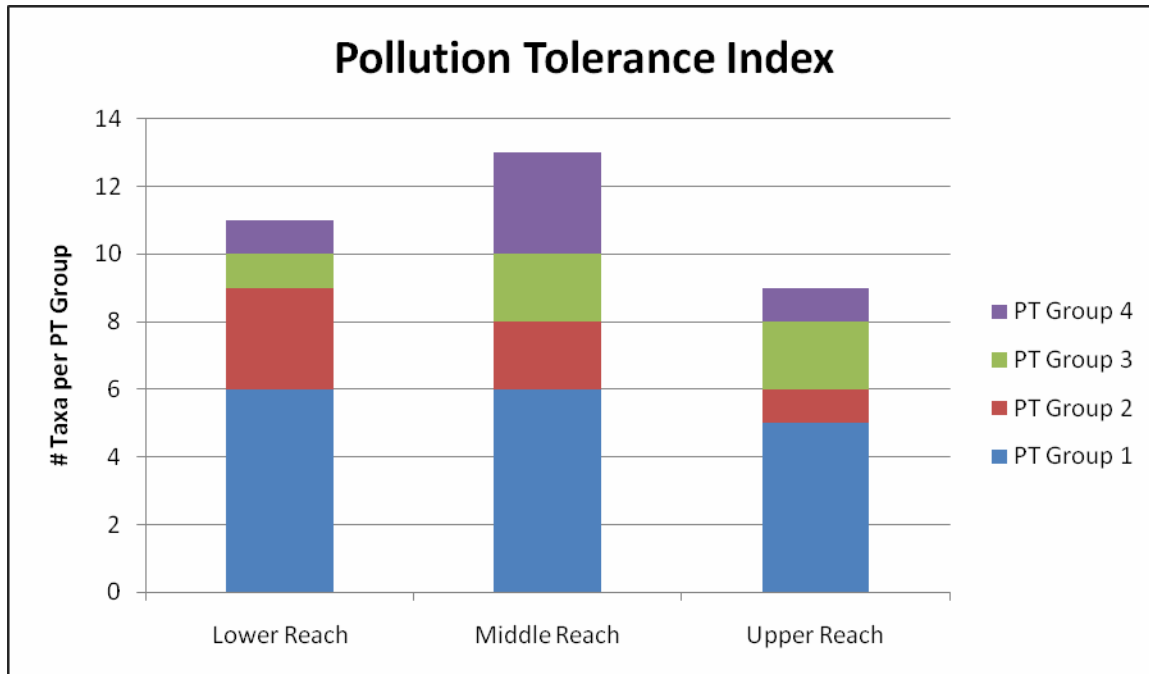
Figure 25. Pollution Tolerance Index rating at each of the EMAP sites.

As shown in Figure 25, the PTI at the upper reach is somewhat lower than that at the middle and lower reach EMAP sites. Possible explanations for this unexpected result include: 1) the reach was evaluated at the peak of spring runoff and soon enough after the winter thaw that a fully

diverse population of organisms had not developed; 2) inconsistent collection and/or identification procedures as a result of this reach being the first site visited by the research team. Regardless of this potential inconsistency, it can be said that, based on this benthic macroinvertebrate rating scale, the Mora River shows scores reflecting excellent aquatic conditions at all sites investigated.

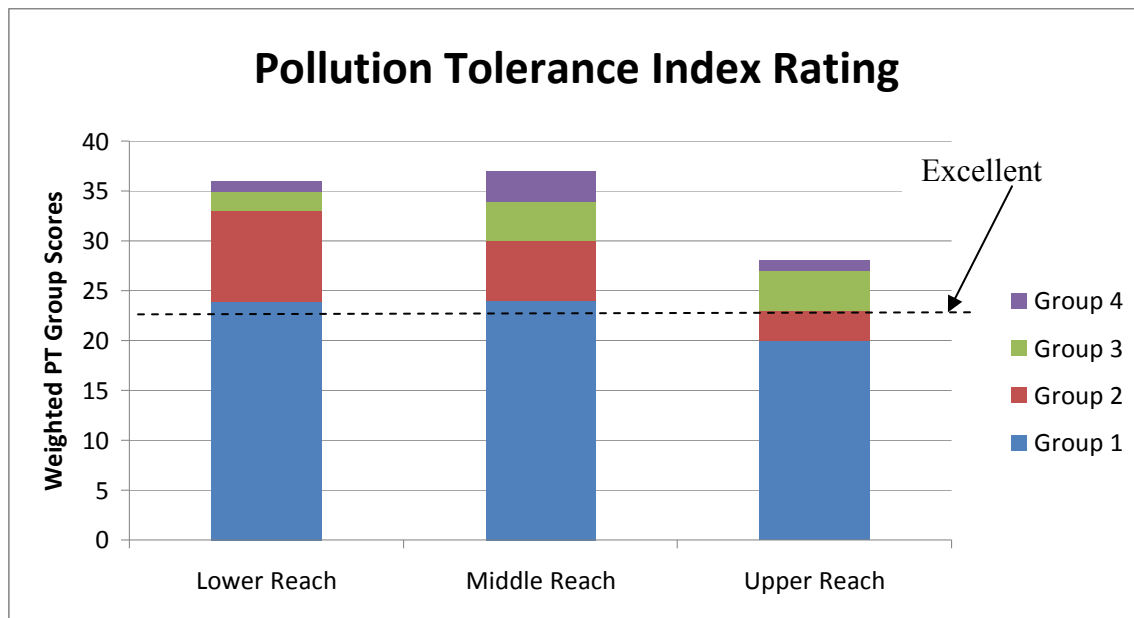
Figure 26 Weighted Pollution Tolerance Index Rating at each of the EMAP sites
